## **EXPERT OPINION**

### **Handrail Coating**

**Report-No. 03\_008**

Site: C & A store, Koblenz

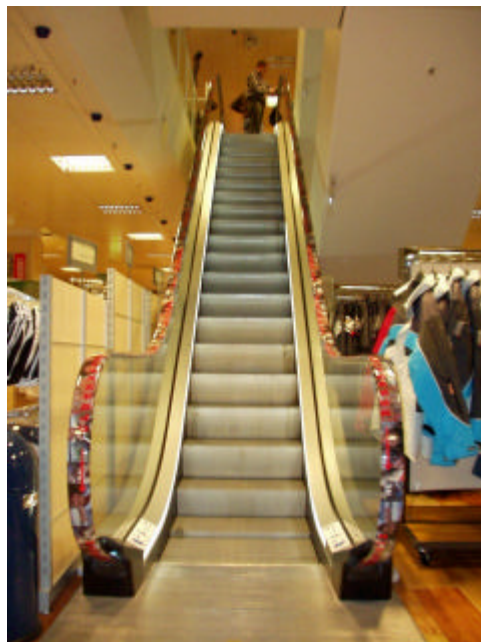
**Fig. 1**

The escalator (Fig. 1) is in excellent condition and maintained at regular intervals by a specialised firm. With all elements of the handrail drive being in a proper state and satisfying the requirements placed by the escalator manufacturer, they have no adverse effect on the handrail (Figs. 2, 3).

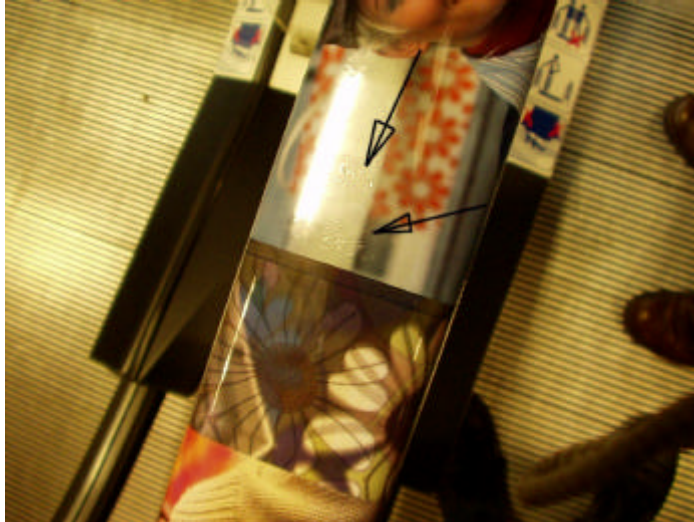
Fig. 4

When the coating is applied to the handrail, small air bubbles may form beneath the film and roughen the surface (Fig. 4). All through the long-duration test, such "imperfections" did not lead to damage or an incipient separation of the coating.

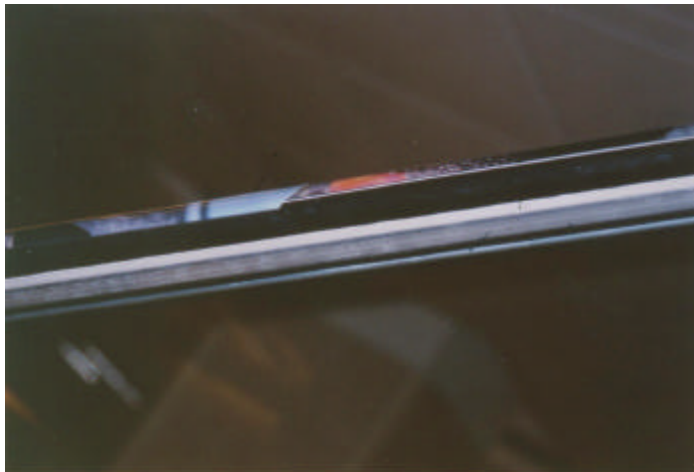
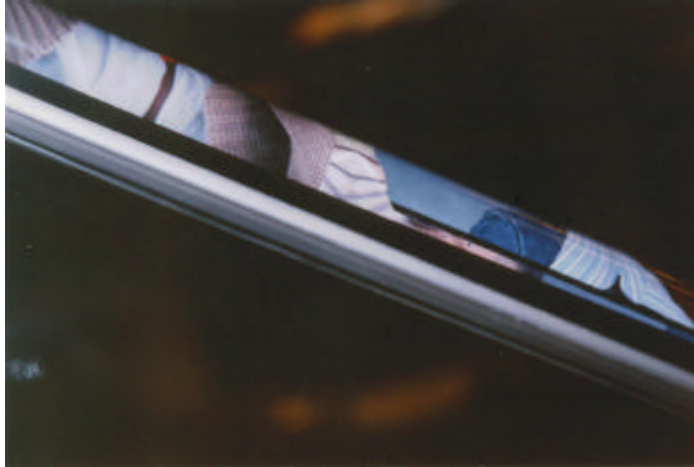
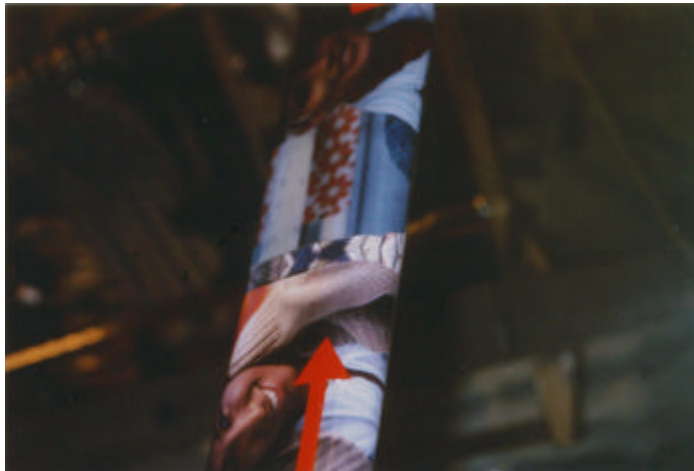
Special attention was given to those areas where the coating overlaps for separations were assumed to occur due to alternating bending load. After half the period of use, the right handrail began to show signs of minor separations (about 2-3 mm) that were the doing of escalator users. Someone must have tried in vain to strip off the film. This incident definitely verified the non-critical behaviour of the coating under conditions of casual vandalism. It was hardly possible to keep on stripping off the film since its adhesion was so great that the mere attempt of detaching a larger area resulted in the breaking off of the bit of film the "vandal" had grabbed at. The protruding parts of the coating were all soft and had no sharp edges or tips; there was no risk of injury. The damaged area could be worked neatly using cutters (Figs. 5, 6, 7).

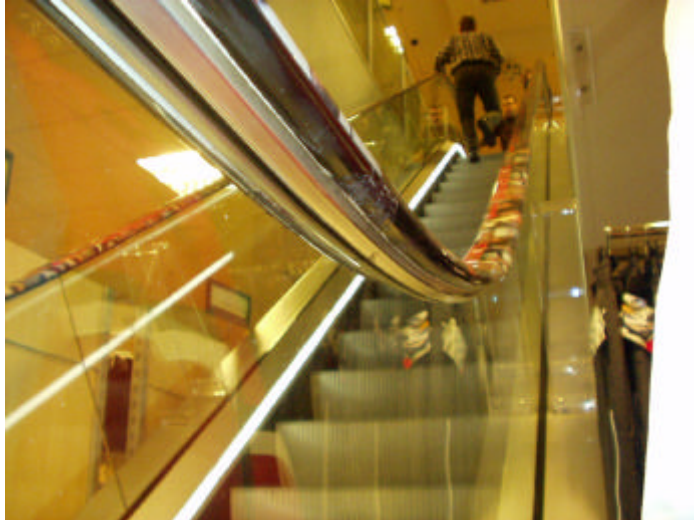
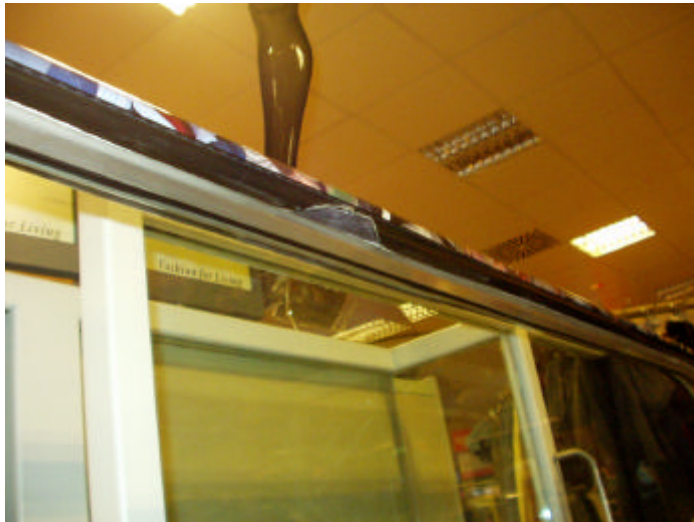
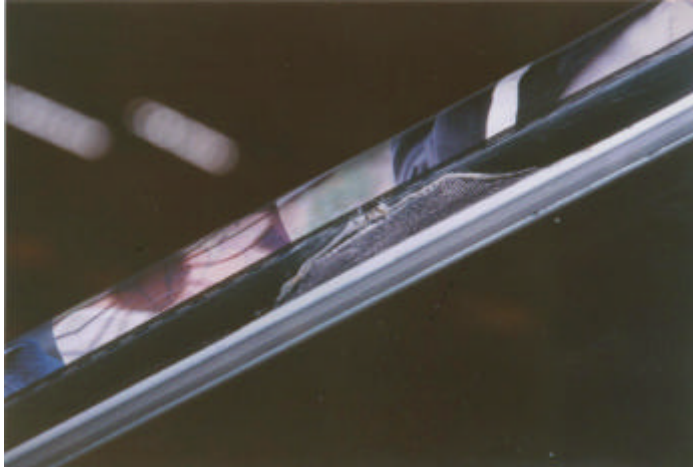
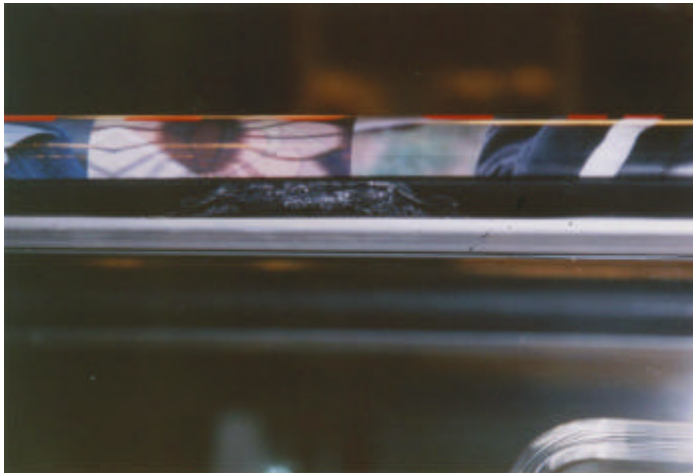
In those areas of the handrails, for instance, the joints, where the surface conditions are less perfect, the behaviour of the coating gave no cause for complaint (Figs. 8, 9, 10, 11).
